NASA/CR-1998-207642

Fabrication and Testing of Mo-Re Heat Pipes Embedded in Carbon/Carbon

David E. Glass
Analytical Services & Materials, Inc., Hampton, VA

Michael A. Merrigan and J. Tom Sena Los Alamos National Laboratory, Los Alamos, NM

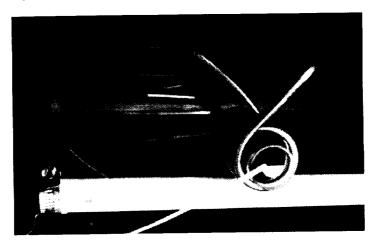
Figure 8: Photograph of the heat pipe in the vacuum chamber showing the heat pipe with thermocouples mounted on the flat surface and induction heating coils wrapped around a portion of the heat pipe.

Inspection of the heat pipe after removal from the vacuum chamber indicated that several of the thermocouple wires were cracked near the location where they were welded to the Ni foil. All of the thermocouple wires were then cut off near where they were welded to the Ni foil. To hold the thermocouple wires steady and to decrease the chance of the wires cracking, the alumina insulation around the thermocouple wires was held in place with thin-gage tantalum wire. The thermocouple wires were then spot welded to the Ni foil on the Mo-Re heat pipe. The heat pipe was then placed in the vacuum chamber for subsequent induction heating.

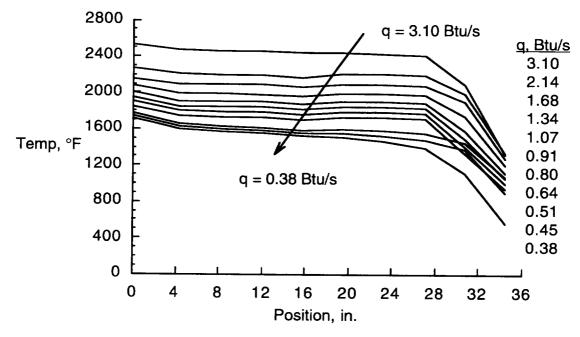
During calibration, the heat pipe was slowly brought to a temperature of 2370°F, and steady state operation was obtained at various intermediate temperatures, as shown in Figure 10. The temperatures were monitored with both an optical pyrometer and thermocouples mounted on the heat pipe. Knowing the steady state temperature of the heat pipe, the heat radiated away (the throughput) could be related to the setting on the

The heat pipe appeared to operate normally and maintained a nearly uniform temperature along its length. As mentioned previously, the first thermocouple was mounted over the endcap. Since it was mounted over the endcap, which was inductively heated but not cooled by the heat pipe, the first thermocouple temperature is slightly higher than the rest of the heat pipe. After the heat pipe reached a steady state temperature of ~2370°F, the power to the heat pipe was turned off and the heat pipe was allowed to cool.

Figure 10: Steady state temperature distributions for a range of heat fluxes. (T = $\pm 1\%$)

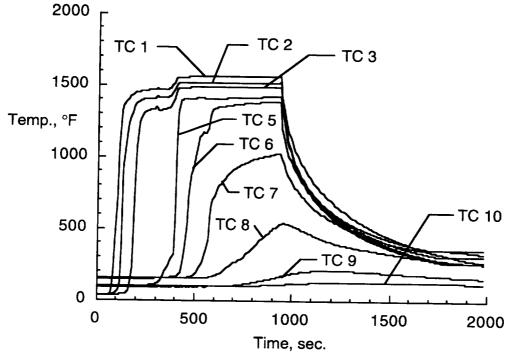
A decision was made to continue testing the heat pipe by starting up the heat pipe with step changes in the applied heat flux occurring every two minutes. The heat pipe began to start up as expected. However, a small jet of vaporized Li was soon observed in the vicinity of the first thermocouple as shown in Figure 11. The heat pipe was operated for another 10 minutes, and then the power to the power supply was turned off. Since the heat pipe was fabricated with a small surplus of Li, and since the rate of mass loss of Li from the leak in the heat pipe was quite small, the operation of the heat pipe would not be effected until all of the surplus Li had escaped from the heat pipe. The region where the leak occurred was at thermocouple number 1. Thermocouple number 1 had been welded to the Ni foil three times, while all other thermocouples had only been welded twice. In addition, all the thermocouple spot welds were done in an open atmosphere. As mentioned previously, the temperature of the heat pipe in the region of the first

thermocouple reached 2820°F. Since the eutectic temperature of Mo and Ni is approximately 2400°F, it is likely that some melting of the heat pipe occurred. When the heat pipes are embedded in C/C, thermocouples will not be welded to the heat pipe, and heat-pipe leaks should not occur.

Though a leak occurred in the heat pipe, the heat pipe did start up from the frozen state as expected. A plot of the temperature versus time from the thermocouples is shown in Figure 12. Thermocouple number 1 is in the evaporator region near the end cap, while thermocouples 2-10 are located in the condenser region. Thermocouple number 4 is not shown on the figure since the data were in error. The sharp gradient at the thermal front can be observed in the figure from the sharp rise in temperature at a given location. The power to the heat pipe was increased at approximately 400 sec, and turned off at approximately 1000 sec.

Figure 12: Temperature versus time at various thermocouple locations during start up from the frozen state of a Li/Mo-Re heat pipe. $(T = \pm 1\% \text{ above } 800^{\circ}\text{F})$

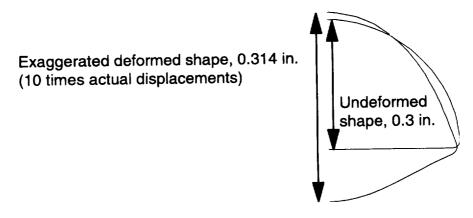
A non-linear structural finite element analysis was conducted to estimate the deformation of the heat pipe during operating conditions. A model of a "D-shaped" tube was generated using PATRAN [15] and the non-linear analysis was performed using NASTRAN [16]. Although the actual heat pipe was 36-in. long, only a 3-in-long segment of the heat pipe was modeled for the finite element analysis. The use of a 3-inlong segment in the finite element model was possible since the finite element analysis confirmed that edge effects of the end of the heat pipe were no longer present 3 in. from the evaporator end of the heat pipe. This length reduction resulted in a significant savings in computer time. The "D-shaped" tube was assumed to have a constant temperature of 2460°F, which resulted in an internal vapor pressure of 16 psi. Since the actual test was conducted in a vacuum chamber, no external pressure was applied in the finite element analysis. A solid end plug was located in the evaporator end of the actual heat pipe. The end plug was modeled in the analysis by restricting both the translations and rotations of one end of the model. Since a complete set of mechanical properties was not available for arc-cast Mo-41Re, temperature dependent stress-strain curves and a temperature dependent coefficient of thermal expansion for powder metallurgy (PM) Mo-50Re were used for most of the analysis. However, yield and ultimate stresses were available for arc-cast Mo-41Re at 2600°F, and the corresponding PM Mo-50Re stressstrain curve was modified to take into account the arc-cast Mo-41Re properties. The non-linear finite element analysis predicted an expansion of only 0.014 in. in the crosssectional expansion of the heat pipe, as shown in Figure 13. The actual growth of the heat pipe was approximately 0.080 in. It is thought that the difference between the actual expansion of the heat pipe and the finite element analysis prediction of the expansion is due to creep.

Figure 13: Schematic of undeformed and deformed shape of "D-shaped" tube from finite element analysis.

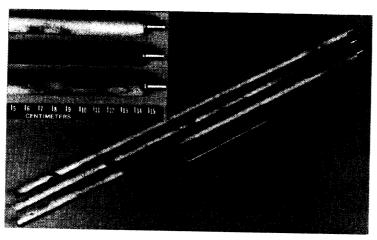
The heat-pipe containers were initially coated with a R512E oxidation protection coating [17]. The intent was to put a coating on the heat pipes that would protect the Mo-Re from both oxidation and carbon diffusion. However, during the firing (for cleaning purposes) of the tubes at LANL, the coating began to evaporate. Due to the required purity for all heat pipe fabrication steps, an attempt was made to remove the coating so that the evaporated coating would not contaminate the heat pipe during subsequent processing. Most of the coating was removed, but as can be seen in Figure 14, not all the heat pipes appeared the same after coating removal. In the top left of the photograph is a closeup view of the end of the heat pipes with covers welded over the fill tubes.

Figure 14: Photograph of the three heat pipes prior to embedding in C/C.

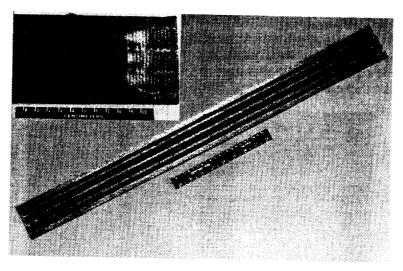
After the heat pipes were tested, they were all three embedded in C/C by Carbon-Carbon Advanced Technologies, Fort Worth, TX. A carbon preform was previously woven by Fiberite, Greenville, TX, with "D-shaped" channels using T-300 fibers. The fabric was heat treated at 3000°F. The heat treatment was not performed at as high a temperature as is often done because the use temperature of the heat-pipe test article is less than 3000°F and higher heat treatment temperatures result in higher modulus fibers. For the application here, the lower modulus fibers resulting from the lower temperature heat treatment is preferable. A 0.005-in-thick layer of Grafoil® (Grafoil® is a registered trademark of Union Carbide) was placed between the curved portion of the heat pipe and the carbon fibers prior to densification. This was done by bonding the Grafoil® to the heat pipes with superglue. The purpose of the Grafoil® was to serve as a compliant layer to relieve stresses due to the CTE mismatch between the Mo-Re and the C/C. A graphite tool was used in the densification process to assure proper positioning of the heat pipes. A photograph of the three heat pipes in the C/C after densification is shown in Figure 16. In the upper left corner of the photograph is a closeup view of the end of the heat pipes in the C/C.

Figure 16: Photograph of the three heat pipes after embedding in C/C.

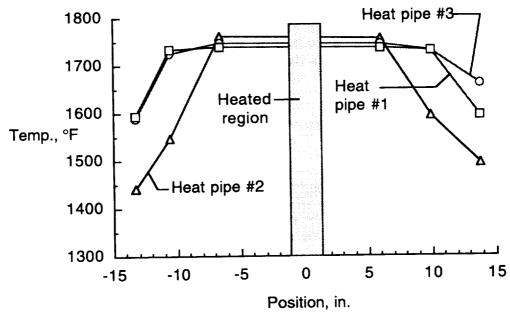
Figure 21: "Steady state" temperatures for each heat pipe (Test 2).

heat pipes. The output from the quartz lamps was approximately 9.5 Btu/s (~10 kW). However, not all 9.5 Btu/s entered the C/C heat pipe test article. The "steady state" temperature distributions on the C/C over each of the heat pipes are shown in Figure 21. The term "steady state" is used, but actually, since the test article was insulated, a true steady state was not obtained. The time required to obtain true steady state conditions would be quite large. "Steady state" is used to describe the condition where only very slow increases in temperature were occurring due to the boundary effect of the insulation. The thermocouples closest to the center of the heat pipes were located underneath the water-cooled heating fixture. Due to radiation to a water cooled boundary, those thermocouples did not read meaningful temperatures and are thus not included in the figure. Heat pipes #1 and #3 were isothermal over a length greater than 20 in. Heat pipe #2 was isothermal over a shorter length than the other two heat pipes. Heat pipe #2 was not entirely isothermal during checkout of the heat pipe prior to embedding it in the C/C (see earlier section on the checkout of the heat pipes). As was mentioned earlier, it appeared that the lower temperatures on this heat pipe were due to non condensable gas (NCG) in the heat pipe.

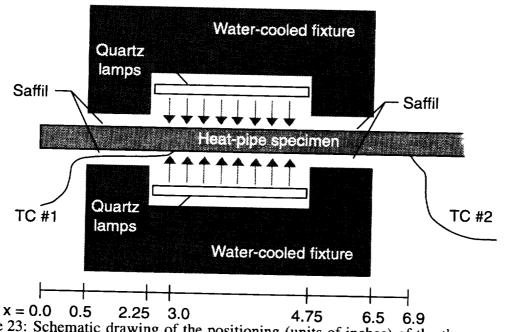
Figure 23: Schematic drawing of the positioning (units of inches) of the thermocouples relative to the water-cooled fixture (not to scale) ($x = \pm 1/16$ in.).

The heat pipe was positioned within the heating fixture such that the heat pipe was heated at one end of the heat pipe. TC #1 (x = 2.9 in.) was located inside the heated region (2.25 in. $\le x \le 4.75$ in.) in order for TC #2 to be outside the heated region, as shown in Figure 23. Saffil® insulation was placed between the heat-pipe test article and the water-cooled fixture to reduce the heat loss radiated to the water-cooled fixture.

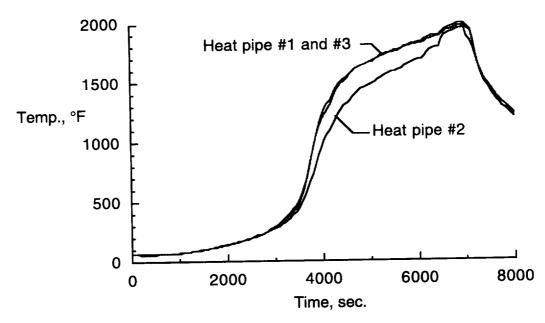
The heat-pipe test article was heated over a time period of approximately 2 hours. Figure 24 shows the temperatures at x = 23.3 in. (TC #6, #22, and #30) as a function of time. Over most of the temperature range after the heat pipes started operating, heat pipe #2 was significantly cooler than heat pipes #1 and #3. However, once the higher temperatures were reached, heat pipe #2 temperatures experienced a sudden increase to the range of the other two heat pipes.

Figure 24: Temperatures at x = 23.3 in. (TC #6, #22, and #30) as a function of time for each of the three heat pipes (Test 5).

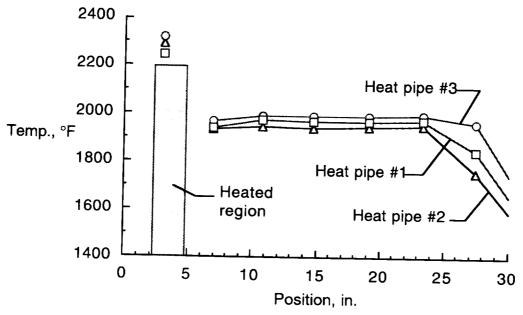
After a few minutes at the maximum heat flux attainable with the quartz lamps, one of the quartz lamps failed and the test was stopped. Figure 25 shows the temperatures at the maximum heat flux levels just prior to the bulb failure. The temperatures were not yet steady state as they appeared to be slowly increasing. The temperature of the thermocouples under the quartz lamps are also shown in Figure 25.

Figure 25: "Steady state" temperatures for each heat pipe in the horizontal orientation (Test 5).

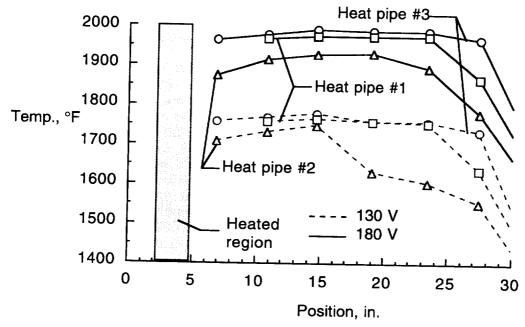
Temperature distributions on the C/C over each of the three heat pipes are shown in Figure 26 at two different heat flux levels. The dashed lines represent the "steady state" temperatures with a voltage of 130 V. The "steady state" temperatures represented by the solid lines are with a voltage of 180 V. The first thermocouple outside of the heated

region on heat pipe #1 (TC #2) was not operating properly and is thus not shown on the figure. Heat pipes #1 and #3 were relatively isothermal over a significant length of the test article, with heat pipe #3 isothermal over a slightly longer length. Heat pipe #2, however, again demonstrated less capability than heat pipes #1 or #3. At the 130 V level, heat pipe #2 was isothermal over a shorter length than the other two heat pipes. At the 180 V level, heat pipe #2 temperatures were still lower than those of the other two heat pipes, and appeared to have a dome-shaped distribution. This is unlike the temperature distribution shown in Figure 25.

Figure 26: Heat-pipe-temperature (on C/C) distributions in the horizontal orientation (Test 6).

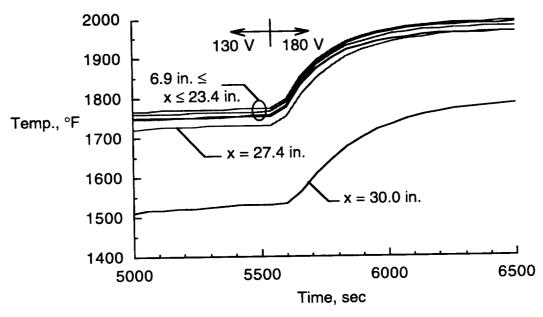
After a "steady state" condition had been maintained at 130 V, the voltage was increased to 180 V. Figure 27 shows the transient temperature from each of the thermocouples over heat pipe #3 prior to and after the increase in voltage. The two thermocouples furthest from the heaters at x = 27.4 in. and x = 30.0 in. are labeled in the figure. The temperatures at the remaining locations were relatively isothermal and are not labeled. As can be seen in Figure 27, the temperatures along the entire length of the heat pipe (even at x = 30.0 in.) increase together. This type of behavior is to be expected for a heat pipe. However, for heat pipes embedded in C/C, differences in thermal resistance (such as contact resistance) would result in different rise times for the temperatures at different locations. Thus the results shown in Figure 27 indicate that the thermal resistance between the heat pipe and the C/C was consistent along the entire length of the test article.

Figure 27: Temperature distribution while transitioning from one steady state condition to another steady state condition in the horizontal orientation (Test 6).

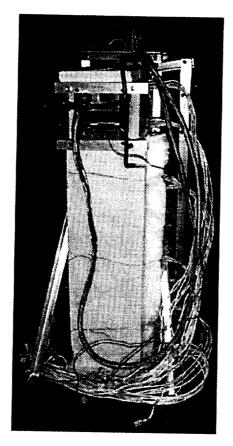
Though most of the testing was performed in the horizontal orientation, testing was also performed with the heat pipes vertical, heated at the top. The test rig with the heater at the top and insulated heat pipe used for the vertical testing are shown in Figure 28. The "steady state" temperature distribution for each of the heat pipes in both the vertical and horizontal orientation is shown in Figure 29. The voltage was 180 V in both tests. Heat pipe #2 had a dome-shaped temperature distribution, with the temperatures near the heated region lower than those near the center of the heat pipe. The temperatures of the vertical heat pipes were slightly higher than the horizontal heat pipes near the heated region. However, at the condenser end of the heat pipes, the vertical heat-pipe temperatures were significantly lower than the horizontal temperatures. Though the voltage to the quartz lamps was the same in both tests, different amount of outgassing products collected on the quartz lamps reflector or slightly different insulation geometry around the heat pipes may have had an influence on the heat-pipe temperatures. In both tests, the thermocouples in the heated regions indicated similar temperatures, indicating that the heat input was not significantly different.

Figure 28: Photograph of the test rig and insulated heat pipe for vertical testing.

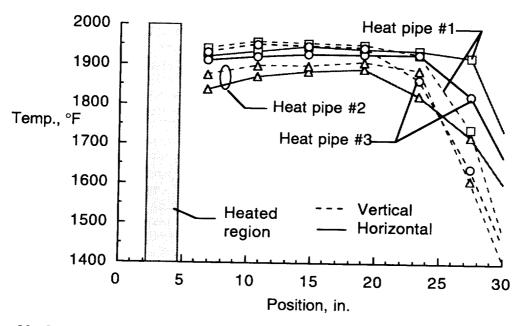
Figure 29: Comparison of "steady state" temperature distributions (180 V) over each heat pipe in both the vertical and horizontal orientation (Test 7&10).

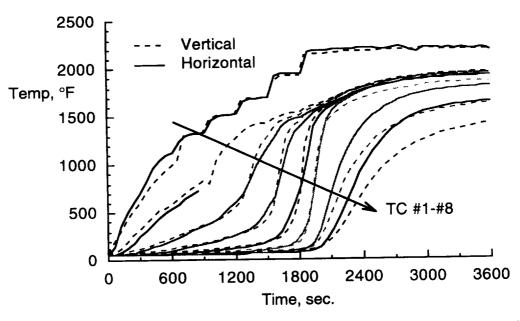
Figure 30: Start-up temperature distributions on heat pipe #1 in the horizontal and vertical orientation.

The transient temperatures over heat pipe #1 in both orientations are shown in Figure 30 for each of the eight thermocouples. The solid lines represent the horizontal orientation and the dashed lines represent the vertical orientation. The first thermocouple (TC #1) was located under the quartz lamps and thus responded much quicker and experienced higher temperatures. Though some difference can be seen in the horizontal and vertical temperatures under the heaters (TC #1), they are similar, indicating similar heat inputs. The thermocouple next to the heated region (TC #2) did not operate properly during a portion of the horizontal test. As a result, its temperatures are shown only during the early stages of the test. The sharp increase in temperatures as the heat-pipe operating length increased down the length of the heat pipe can be seen. At "steady state", the heat pipe was operating isothermally over a greater length in the horizontal orientation than in the vertical orientation. However, during the startup, the horizontal and vertical heat-pipe temperatures were similar. It was only at the higher heat fluxes and at the condenser end of the heat pipes that the vertical heat-pipe temperatures began to lag the horizontal heat-pipe temperatures. Away from the condenser end of the heat pipe, as the heat pipe was starting up, the temperature rise was steeper for the vertical heat pipe than the horizontal heat pipe. This can be observed by noting that the vertical heat-pipe temperature rise starts after the horizontal heat-pipe temperature rise, but levels off prior to the horizontal heat-pipe temperatures.

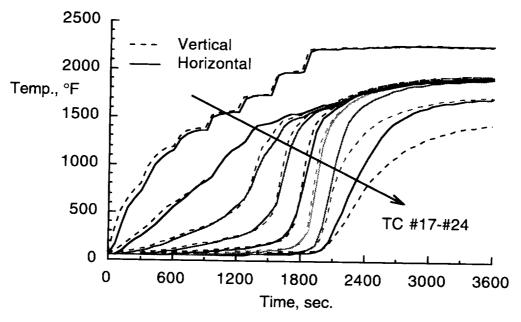
The temperatures over heat pipe #3, the center heat pipe in the test article, can be seen in Figure 31 in both the horizontal and vertical orientation. The thermocouple next to the heated region (TC #2) did not operate properly during a portion of the horizontal test. As a result, its temperatures are shown only during the early stages of the test. The temperatures are similar to those in Figure 30, except that the isothermal length was

Figure 31: Start-up temperature distributions on heat pipe #3 in the horizontal and vertical orientation.

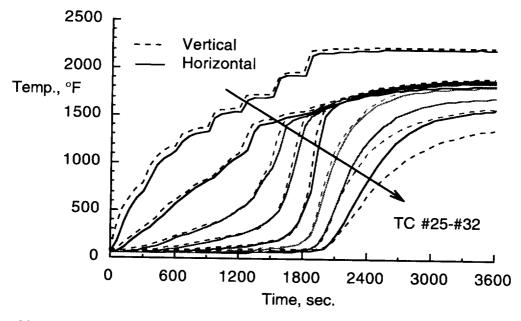
slightly longer. Figure 32 shows the temperatures over heat pipe #2 during the start up. Heat pipes #1 and #2 were on the sides of the test article, sandwiching heat pipe #3 between them. That may contribute to the fact that the middle heat pipe (heat pipe #3) was, in general, isothermal over a longer length than either of the two heat pipes on the sides.

Figure 32: Start-up temperature distributions on heat pipe #2 in the horizontal and vertical orientation.

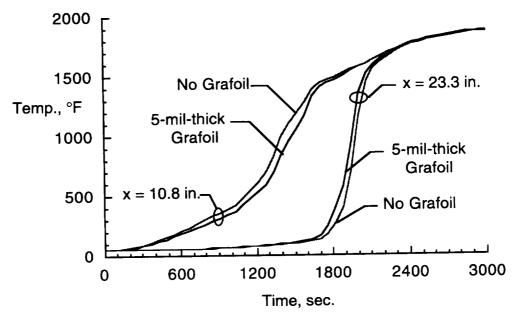
thermal resistance. Figure 33 shows the transient temperatures at x = 10.8 in. and x = 23.3 in. on both the flat (no Grafoil®) and curved (with Grafoil®) surfaces with the heat pipes in the horizontal orientation. At x = 10.8 in., the temperature of the surface with no Grafoil® increased faster than the surface with Grafoil® between the heat pipe and the C/C. That was as expected since the Grafoil® should result in increased thermal resistance. However, at x = 23.3 in., the surface with no Grafoil® between the C/C and the heat pipe increased slower than the surface with the Grafoil®. The difference in thermal response at the two locations was also present in other horizontal tests and with the heat pipes in the vertical orientation.

Figure 33: Comparison of temperature rise with and without 5-mil-thick Grafoil® between heat pipe #1 and the C/C with the heat pipe in a horizontal orientation (Test 7).

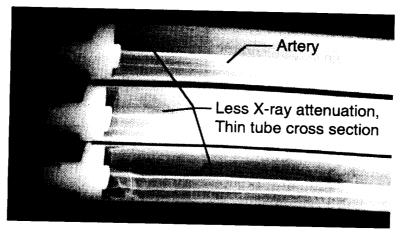
Additional radiography was performed on the heat pipes after testing. The distance between the heat pipes was measured from the X-rays, and found to be slightly different between different heat pipes. The distance between the heat pipes varied along the length, but was approximately 0.075 in. and 0.085 in. One gap was noticeably (~0.010 in.) wider than the other gap. The spacing was to have been 0.040 in, indicating that the gaps were approximately twice the design gap.

Figure 34: X-ray of the three heat pipes embedded in C/C showing the arteries in the heat pipe and areas of less attenuation.

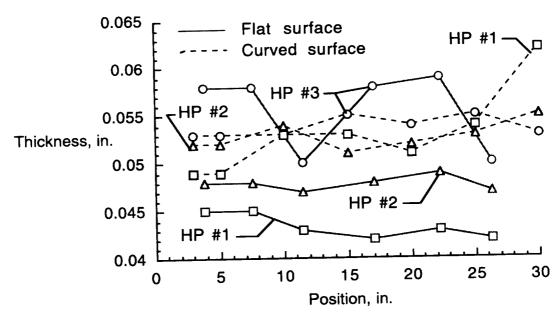
Figure 36 graphically shows the thicknesses along the length of each heat pipe. As in Table 2, the thickness of the container is not included. A disbond, or gap, appears to be present on the flat surface of the center heat pipe (HP #3) at locations x = 3 3/4 in. and x = 7 1/2 in. This hypothesis is based on both the larger thickness and the sound generated by tapping on the C/C. On the same heat pipe, at x = 17 in. and x = 22 1/4 in., the sound

Figure 36: Plot of thickness data (less heat-pipe container) from eddy current tests.

During testing, heat pipe #1 appeared to operate the best and have consistently high steady state temperature distributions. That is consistent with Figure 36, which indicates the thinnest C/C is over the flat surface of heat pipe #1. However, for heat pipes #2 and #3, the thickness and temperatures did not always correlate. This may be due to the differences in the heat-pipe operation, i.e., presence of NCG, or from the fact that the entire test article was insulated.
